AVIATION INVESTIGATION REPORT

A09A0016

MAIN GEARBOX MALFUNCTION / COLLISION WITH WATER

SIKORSKY S-92A, C-GZCH

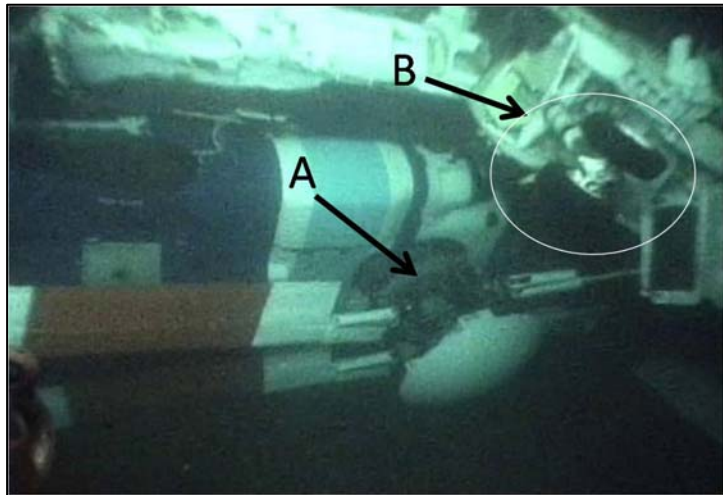
The cockpit was extensively damaged and had structurally separated from the main fuselage. Both crew emergency exit windows had been detached by the force of the impact as the cockpit fuselage structure had been severely crushed. The cockpit area, including the flight controls and instrument panel, from the nose rearward to where the cockpit joins the main fuselage, was found lying under much of the forward cabin wreckage. The left-hand pilot seat had remained attached to the cockpit structure but the right-hand pilot seat had separated from its attachment structure.

Photo 1. Photo taken by remotely operated vehicle prior to recovery: A - main rotor; B - main landing gear.

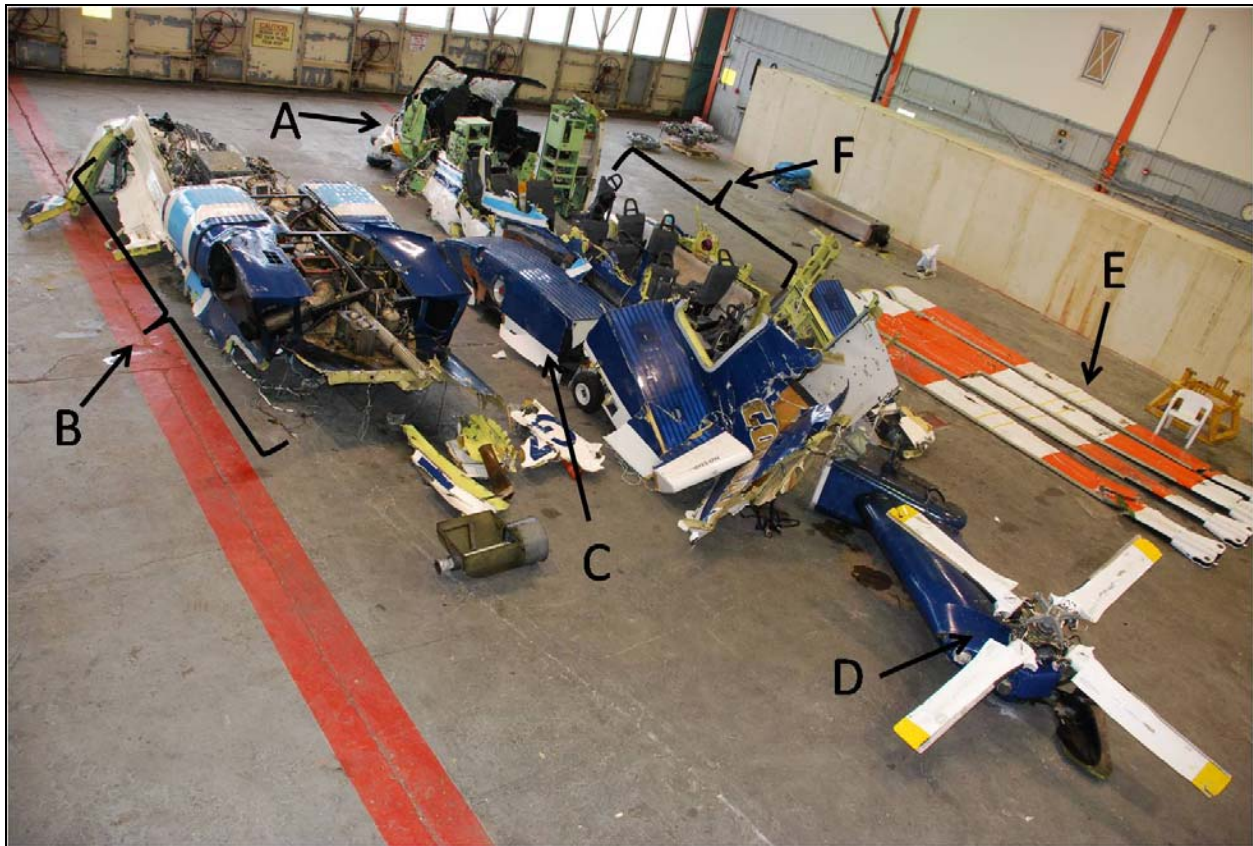
The helicopter impacted the water with a high downward velocity. The extensive break-up of the passenger cabin and floor, and the comparatively intact roof above was consistent with the helicopter having been upright at impact. Due to the sea state conditions (about 2.5 metres significant wave height) it was not possible to establish an exact helicopter attitude at the time of impact (see Photo 5). However, damage to the airframe indicated that both the cockpit and the tail pylon broke in a downward direction.

The relative integrity of the main rotor blades is consistent with a low blade energy state at the time of water impact. The tail rotor blades showed no sign of rotation at impact.

Photo 5. CHI91 wreckage layout: A - Cockpit; B - Upper deck/engines; C - Sponson; D - Tail rotor; E - Main rotor blades; F - Cabin area

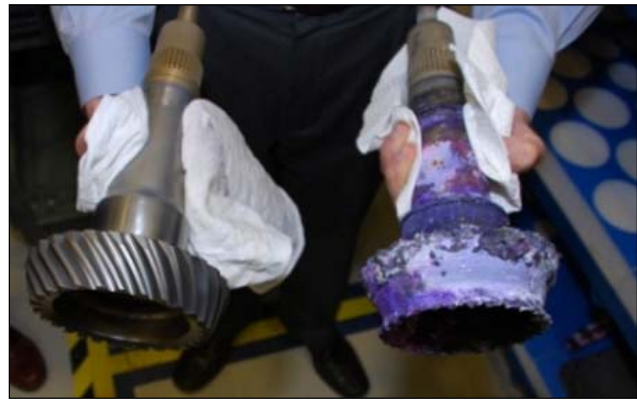
The helicopter's MGB operated for approximately 11 minutes after the total loss of lubricating oil pressure. Examination of the MGB components showed damage due to frictional heating caused by the continued operation without oil. This frictional heating led to the plastic collapse of the tail take-off pinion's teeth, eventually causing the loss of drive to the tail rotor shafts (see Photo 6, damaged pinion compared to exemplar). There was no indication of component seizure that would have prevented the main rotor from free-turning at the time of impact. The tail take-off pinion shaft is held in position in the radial and axial directions by two tapered roller bearings and these bearings had damage consistent with operation under inadequate lubrication. Their failure would have caused a loss of radial and axial constraint of the rotor brake disc. The disc-type rotor brake system is designed to stop the rotors with both engines off when Nr is at 40% (decreasing) within 30 seconds of application.

Photo 6. Damaged tail take-off pinion on right

Approximately 1.5 seconds before the MPFR stopped recording, there was a 1 to 2 seconds "ROTOR BRAKE ON" indication. Although there was no indication of abnormal contact between the rotor brake disc and brake pads, the activation of any of the switches in the brake callipers could have been caused by an impact or impacts between the rotor brake disc and the brake wear liners caused by the deterioration of the tail take-off pinion and bearings.

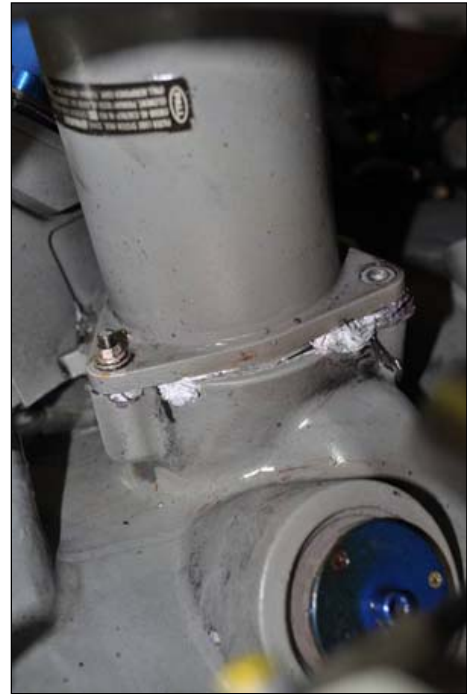
Multiple indentations were noted on the bottom of the oil filter bowl. Sikorsky has observed indentations on brand new bowls and indicated that during normal operation, when the components are assembled correctly, it is possible that once the oil pressure is applied it forces the filter element against the bowl with enough force to create the indentations. Similar indentations were reported to be observed in the MGB oil filter bowl removed from a helicopter involved in an occurrence in Australia (see Section 1.18.3.2). It was determined that these filter bowl indentations did not contribute to the failure of the MGB filter bowl mounting studs on CHI91.

Photo 7. CHI91 oil filter bowl

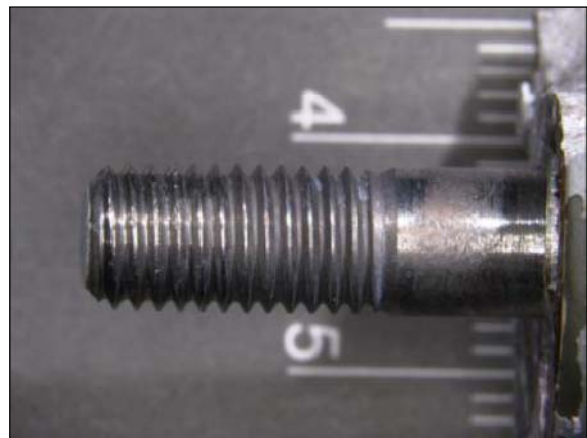
The TSB was able to examine the top stud which remained in CHI91's MGB housing (see Photo 8) and conduct testing on a sampling of new stud and nut assemblies, which were provided by Sikorsky, to quantify the nut and stud damage and the effect on preload associated with a certain number of assembly cycles. Examination of a new stud and nut showed that galling damage developed after the first installation and that the damage became progressively more severe with repeated installation/removal cycles (see Photo 9). Testing of the occurrence and exemplar studs and nuts showed that after 13 to 17 assembly cycles, the nut self-locking feature was significantly damaged and fragments were separating from the crests of the threads.

Photo 8. Top stud which remained in CHI91's MGB housing.

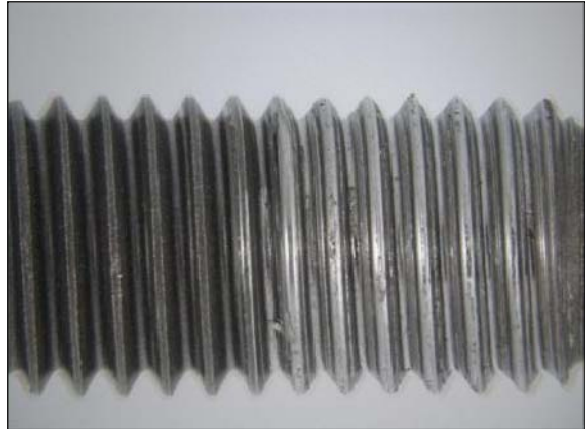
Photo 9. New exemplar stud – Left side original threads, right side after 10 installation/removal cycles using the same nut.

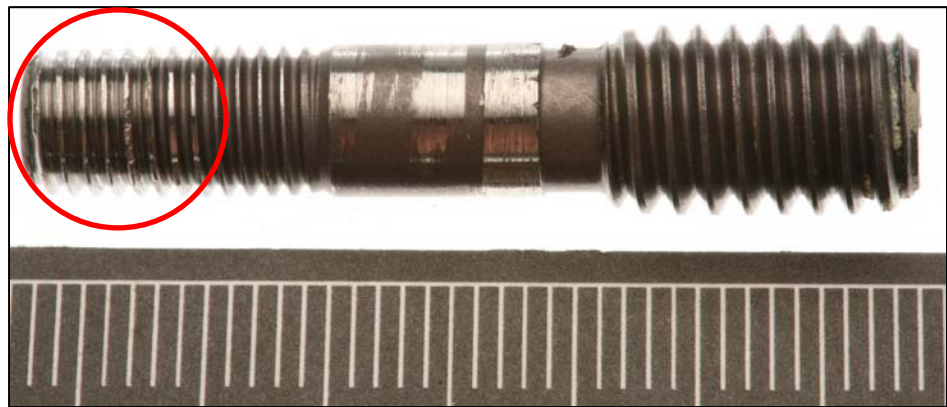
Galling was observed on the threads of the occurrence helicopter's studs, as well as on some of the studs removed from other Cougar helicopters. The galling noted on these studs would have been detectable using 10X magnification, and on some studs the damage would have been visible without the aid of magnification (see circled area – Photo 15). The TSB examination suggested that the occurrence nuts and studs had accumulated sufficient galling damage to prevent the correct preload from being applied during installation. The reduced preload led to an increase of the cyclic load experienced by the studs during operation and to initiation and propagation of fatigue cracks. The TSB's examination of new studs found that even though the studs were manufactured with a coating to prevent galling, galling damage developed after the first installation of a nut, and the damage became more severe the more frequently the nut was removed and re-installed. The occurrence helicopter, as well as at least three other Cougar helicopters, had MGB oil filter bowl attachment nuts with a grey paint residue that had been applied when the MGB was manufactured.

Photo 15. Stud removed from another Cougar Helicopters' MGB (scale in mm)

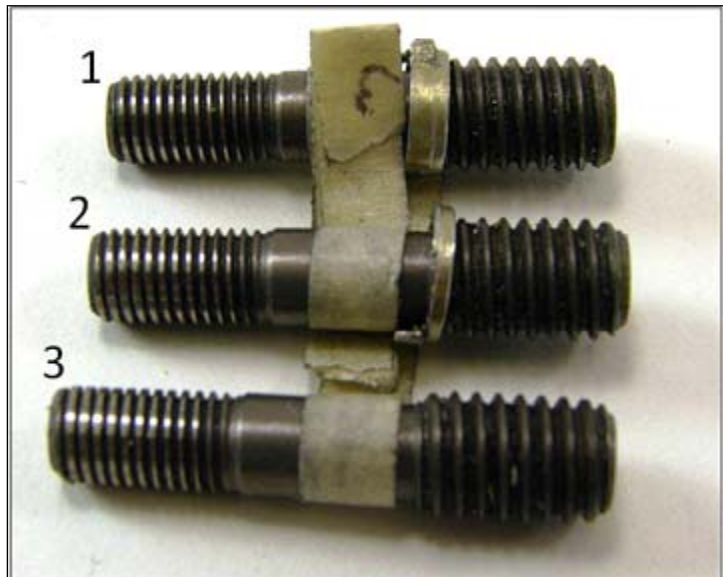
Revision 13 in November 2008 and when AD 2009-07-53 was issued in March 2009. However, it did receive 59 studs from various operators after they had complied with the AD. Sikorsky examined these studs and found that they had varying degrees of galling of the threads, indicating multiple nut removals. Some of

Photo 16. Studs returned to Sikorsky
