AVIATION INVESTIGATION REPORT

A09A0016

MAIN GEARBOX MALFUNCTION / COLLISION WITH WATER

SIKORSKY S-92A, C-GZCH

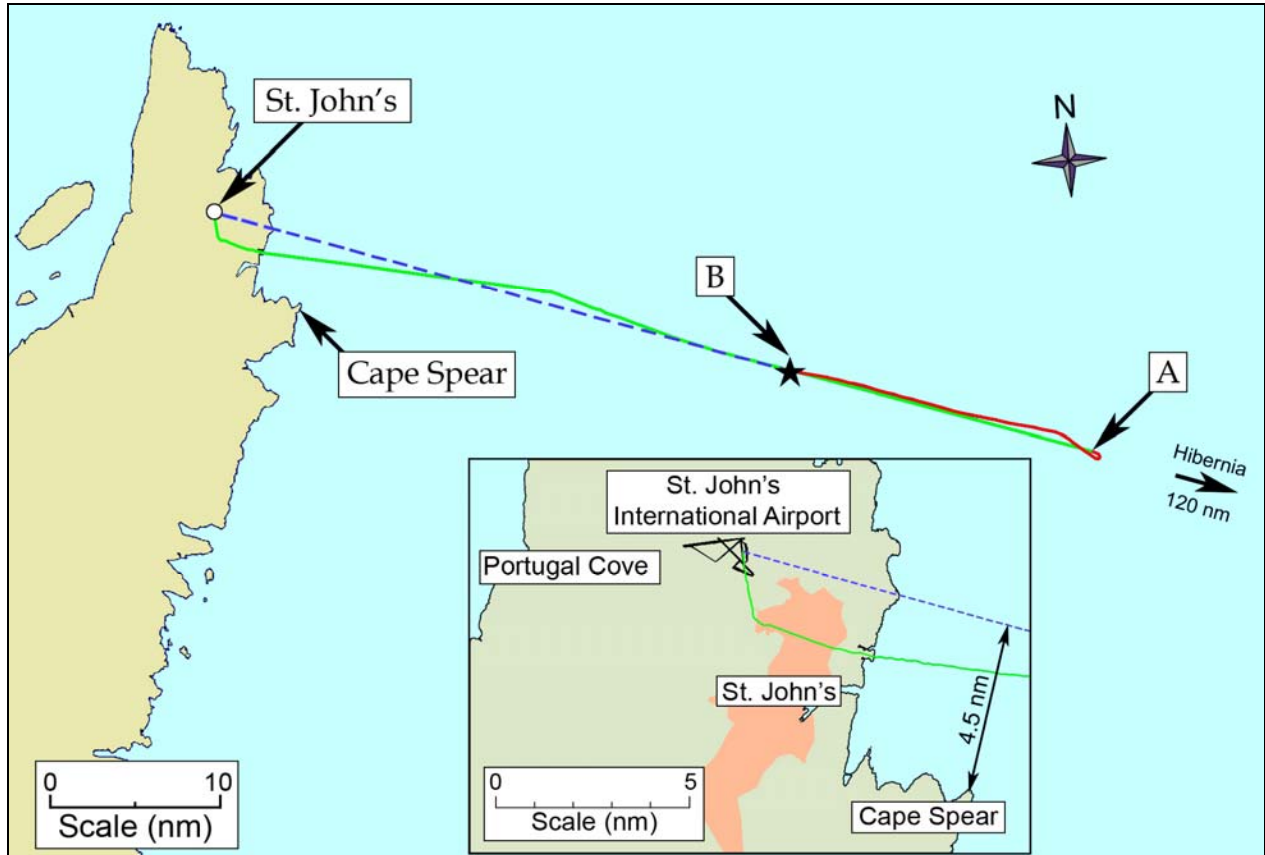
Figure 1. Area map with helicopter track and impact position

Figure 1 depicts the outbound portion of CHI91's flight path prior to the red MGB OIL PRES warning message (solid green line), the point where the oil pressure loss occurred (see Point A), the return portion of the flight (red line), and the approximate position it impacted with the water (see Point B). The blue dashed line is the projected track from the impact position direct to CYYT. The inset shown in Figure 1 depicts the distance between Cape Spear and the direct track followed by the helicopter, from the diversion point to CYYT.

The accident location was approximately 35 nautical miles (nm) from CYYT (approximate position of 47°26'03"N, 051°56'35"W), on a direct track between the diversion point and CYYT (see Figure 1).

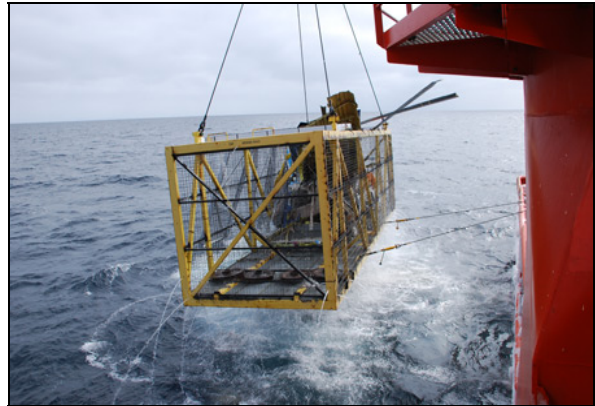
Photo 18. Main wreckage recovery

By 17 March 2009, all victims had been recovered as well as the MPFR. Due to the fragile condition of the main wreckage, the TSB determined early in the recovery operation that it would not be effective or safe to lift the main wreckage, unsupported, to the surface and onto the ship. With this in mind, a rigid spool deployment frame was modified to serve as a large cage. After two of the main rotor blades were cut underwater to allow the wreckage to sit in the cage, a strap was secured around the main rotor head and used to lift the main wreckage into the cage, and then the cage was lifted to the surface (see Photo 18). The *Atlantic Osprey*, with the main wreckage aboard, arrived in St. John's harbour the afternoon of 18 March 2009.
